**LYNDE CREEK WATERSHED  
EXISTING CONDITIONS REPORT  
CHAPTER 13 – FLUVIAL GEOMORPHOLOGY**

**June 2008**

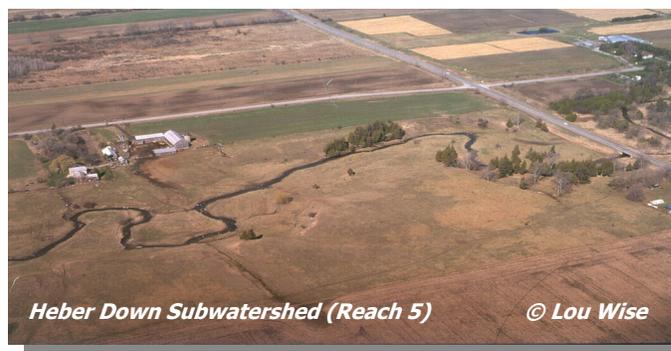
Reach 5 is currently utilized for cattle pasture, although subdivision applications and construction work are active within the reach. The area is impacted by long-term agricultural activity, and is characterized by short grass and sparse cedar trees. Cattle were evident in the reach at the time of the site walk, and trampled stream bank areas were numerous. Active erosion is evident along outside bends due to the lack of deep-rooted vegetation on the stream banks.

*'Reach 5 is currently utilized for cattle pasture, although subdivision applications and construction work are active within the reach'*
