**LYNDE CREEK WATERSHED
EXISTING CONDITIONS REPORT
CHAPTER 16 – FISHERIES & AQUATIC HABITAT**

June 2008

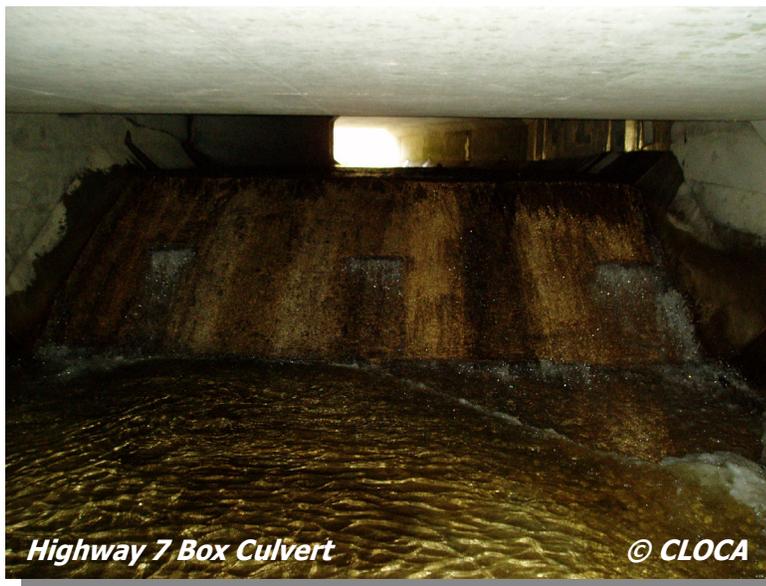
Highway 7 Box Culvert

The Highway 7 culvert appears to have been modified several times since the initial installation to accommodate road widening. The culvert is a two metre concrete box including a ramp angle of 45° which precludes passage by fish. Removal or redesign of this culvert would facilitate fish passage, but the presence of reddsides dace upstream from the structure should be considered before remediation works take place. The culvert currently restricts access to approximately 9.5km of creek.

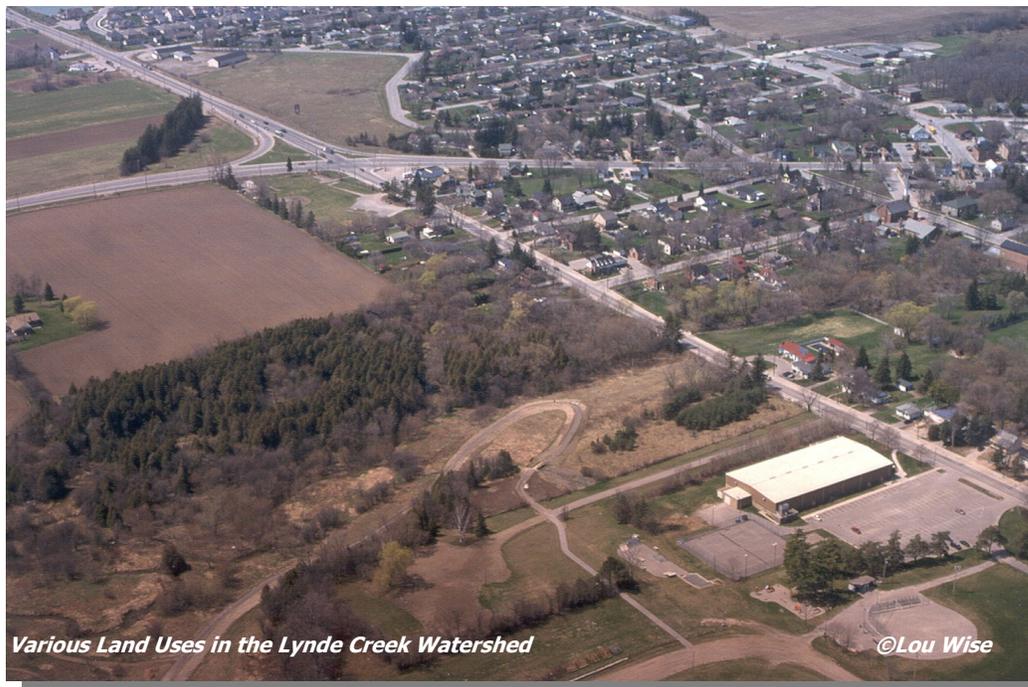
'Environment Canada guidelines (EC, 2004) indicate that 75% of stream length should have 30m riparian vegetation buffers on each side of the stream'

'all watercourses within the Myrtle Station subwatershed have moderate LDI values'

The entire subwatershed has 35% riparian cover (the second highest proportion of any Lynde Creek subwatershed); while first-order streams have only 23% cover. The dominant land use/land cover types within the subwatershed are agriculture (59%), forest (17%) and urban development (9%). All watercourses within the Myrtle Station subwatershed have moderate LDI values (Figure 24). Factors contributing to the moderate ratings are likely insufficient riparian cover, presence of instream barriers and dominance of agricultural and urban land uses.

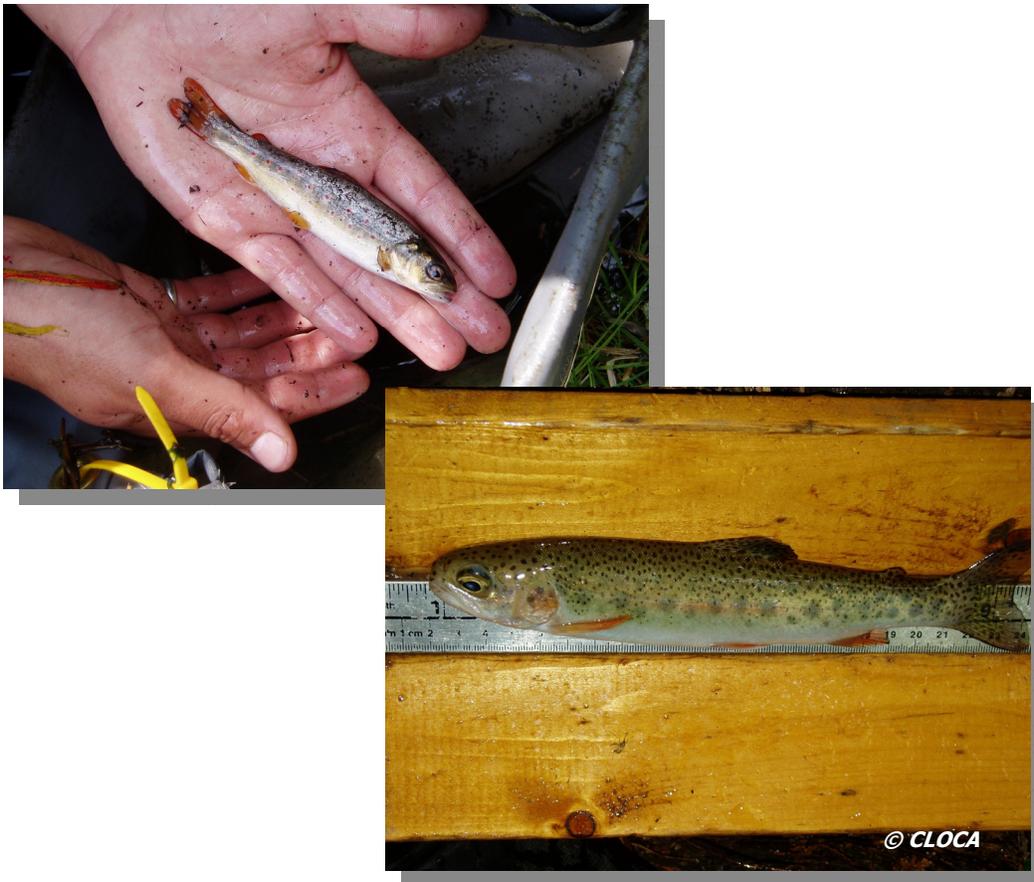
'the Myrtle Station subwatershed has a very diverse cold/cool-water fish community of 14 species from 8 families'

Figure 25 depicts the fish sampling sites as part of the 2001 aquatic monitoring program within the subwatershed. The Myrtle Station subwatershed has a very diverse cold/cool-water fish community of 14 species from 8 families (CLOCA, 2006; CLOCA/MNR, 2007). Fish species caught in the creek are representative of cool and cold-water fish typical of low stream-order trout streams (sucker, sculpin, dace and trout; Moyle and Cech, 2000) in addition to warm-water fish. Redside dace, a species of concern federally and a provincially threatened species are found in this subwatershed. Redside dace is very sensitive to habitat changes, in particular changes to water temperature and turbidity. It has been found that in the Greater Toronto Area, the availability of suitable habitat has declined significantly as a result of increased land development (Holm and Crossman, 1986; RSD Recovery Team, 2005).
