WILDLIFE CORRIDOR PROTECTION & ENHANCEMENT PLAN

Action Plan #5

Central
Lake Ontario
Conservation

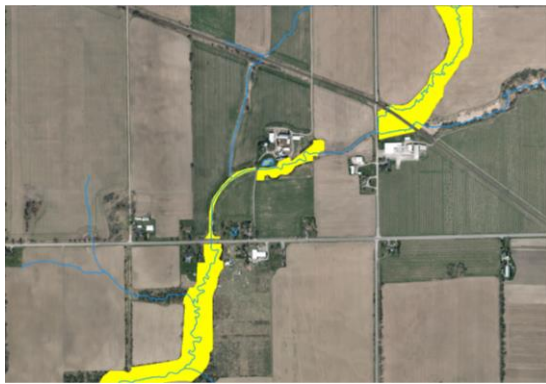
1. Map existing vegetation within corridors.

In order to provide recommendations about how to improve the Wildlife Habitat Network in the CLOCA jurisdiction, a secondary mapping exercise was undertaken as part of the Action Plan process to determine where gaps and barriers might exist. *Corridor Gaps*, i.e., areas within the corridors lacking natural cover, were identified by generating an 'ideal' corridor layer in ArcView and comparing this to the existing corridor layer; this 'ideal' layer was developed using the creek layer, since the majority of corridors follow creeks in the watersheds. The creeks were

buffered by 50 m on either side for landscape corridors, and 30 m on either side for local corridors: in instances where there were no existing creeks between two habitat areas, the corridors were drawn in by hand. The 'ideal' regional corridor layer was produced using a 1 km buffer of the Lake Ontario Shoreline, and modified versions of the Lake Iroquois Beach and Oak Ridges Moraine physiographic layers. These 'ideal' layers, when displayed beneath the existing corridor layer for each watershed, highlight those areas within each corridor that are lacking in natural cover. The contrast between them makes the areas to target for restoration readily identifiable.

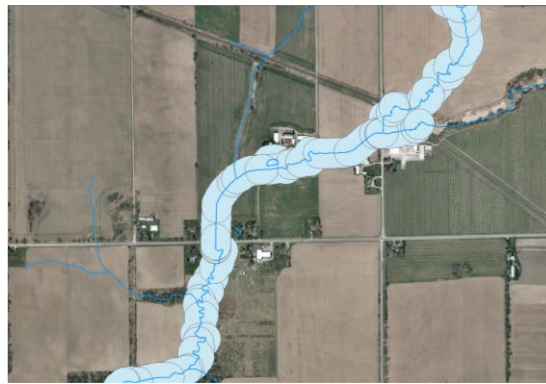
2. Buffer the creek layer to determine the recommended width of landscape and local corridors and refine if needed.

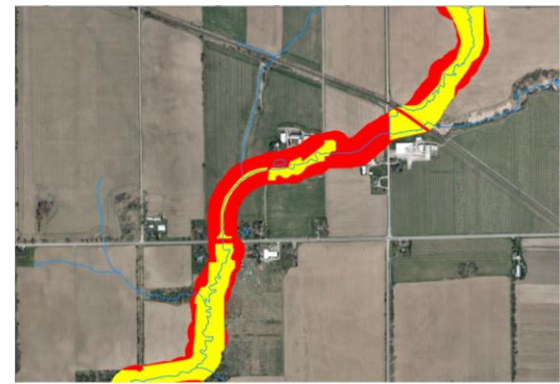
3. Overlay the 'ideal' corridor layer and the existing vegetation layers to show desired corridor width and highlight corridor gaps.

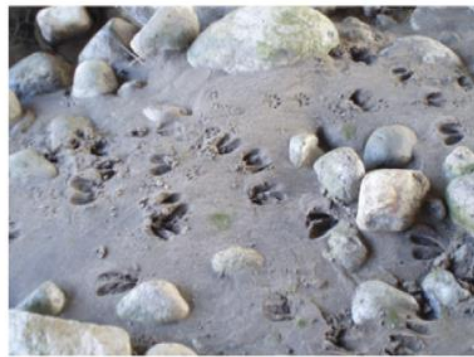
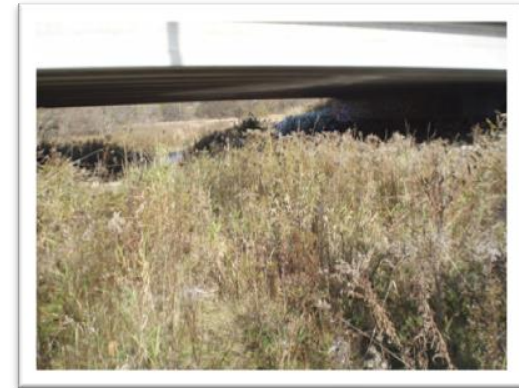
- 52: Animal tracks under the bridge.
 53: Bridge, taken from south side.
