**LYNDE CREEK WATERSHED  
EXISTING CONDITIONS REPORT  
CHAPTER 13 – FLUVIAL GEOMORPHOLOGY**

**June 2008**

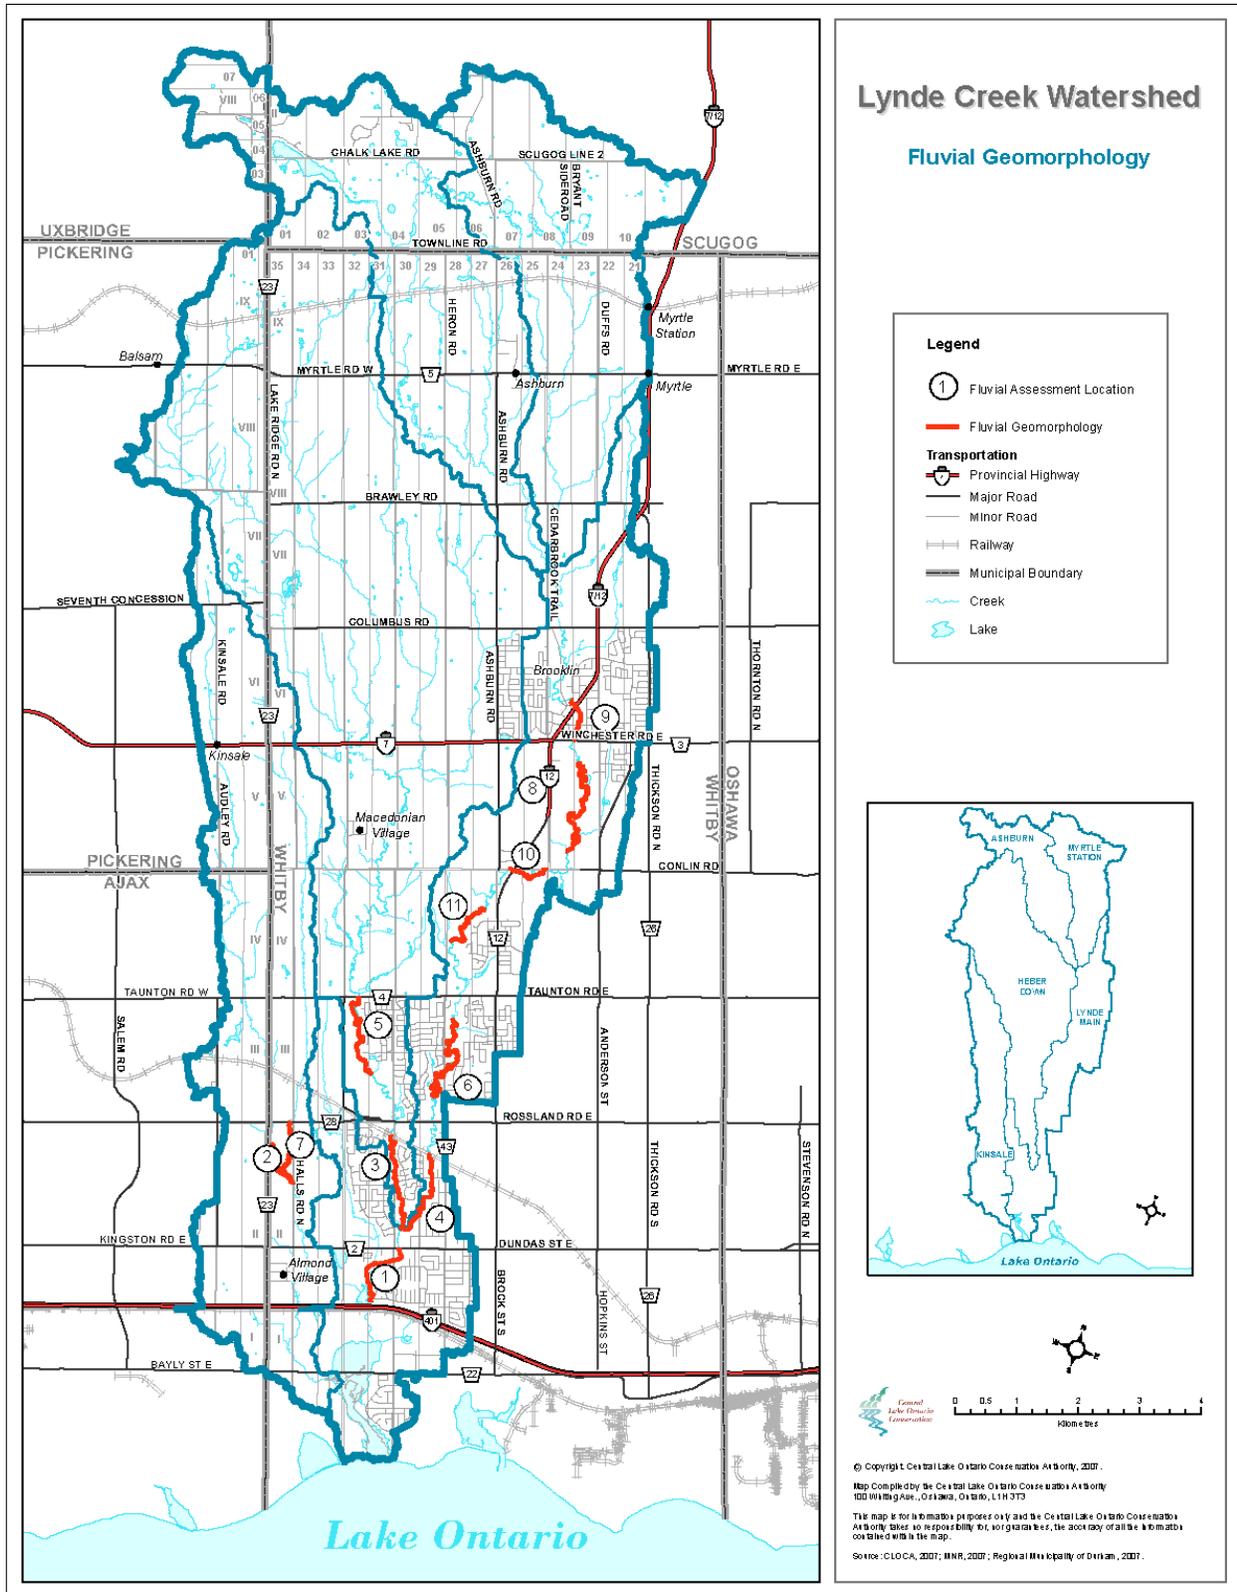
Figure 2: Location of fluvial geomorphic assessments in the Lynde Creek watershed.

Figure 3 delineates the reaches where the field assessments were completed. The geomorphology of Lynde Creek is typical of moraine-fed streams draining to Lake Ontario. The Moraine itself is generally able to hold and infiltrate precipitation into groundwater, and does not produce sufficient surface water to cause the formation of streams. Additionally the hummocky topography that characterizes the Moraine promotes infiltration as numerous sinks trap surface water between mounds forcing it to percolate into the ground. The headwater streams therefore originate on the south shoulder of the Moraine where in many cases groundwater discharges to the ground surface. As these small streams flow through the Till Plain, the topography becomes much more uniform, with a significant north to south slope. The till soils are erodible, and over time steep gullies and valleys have been created.

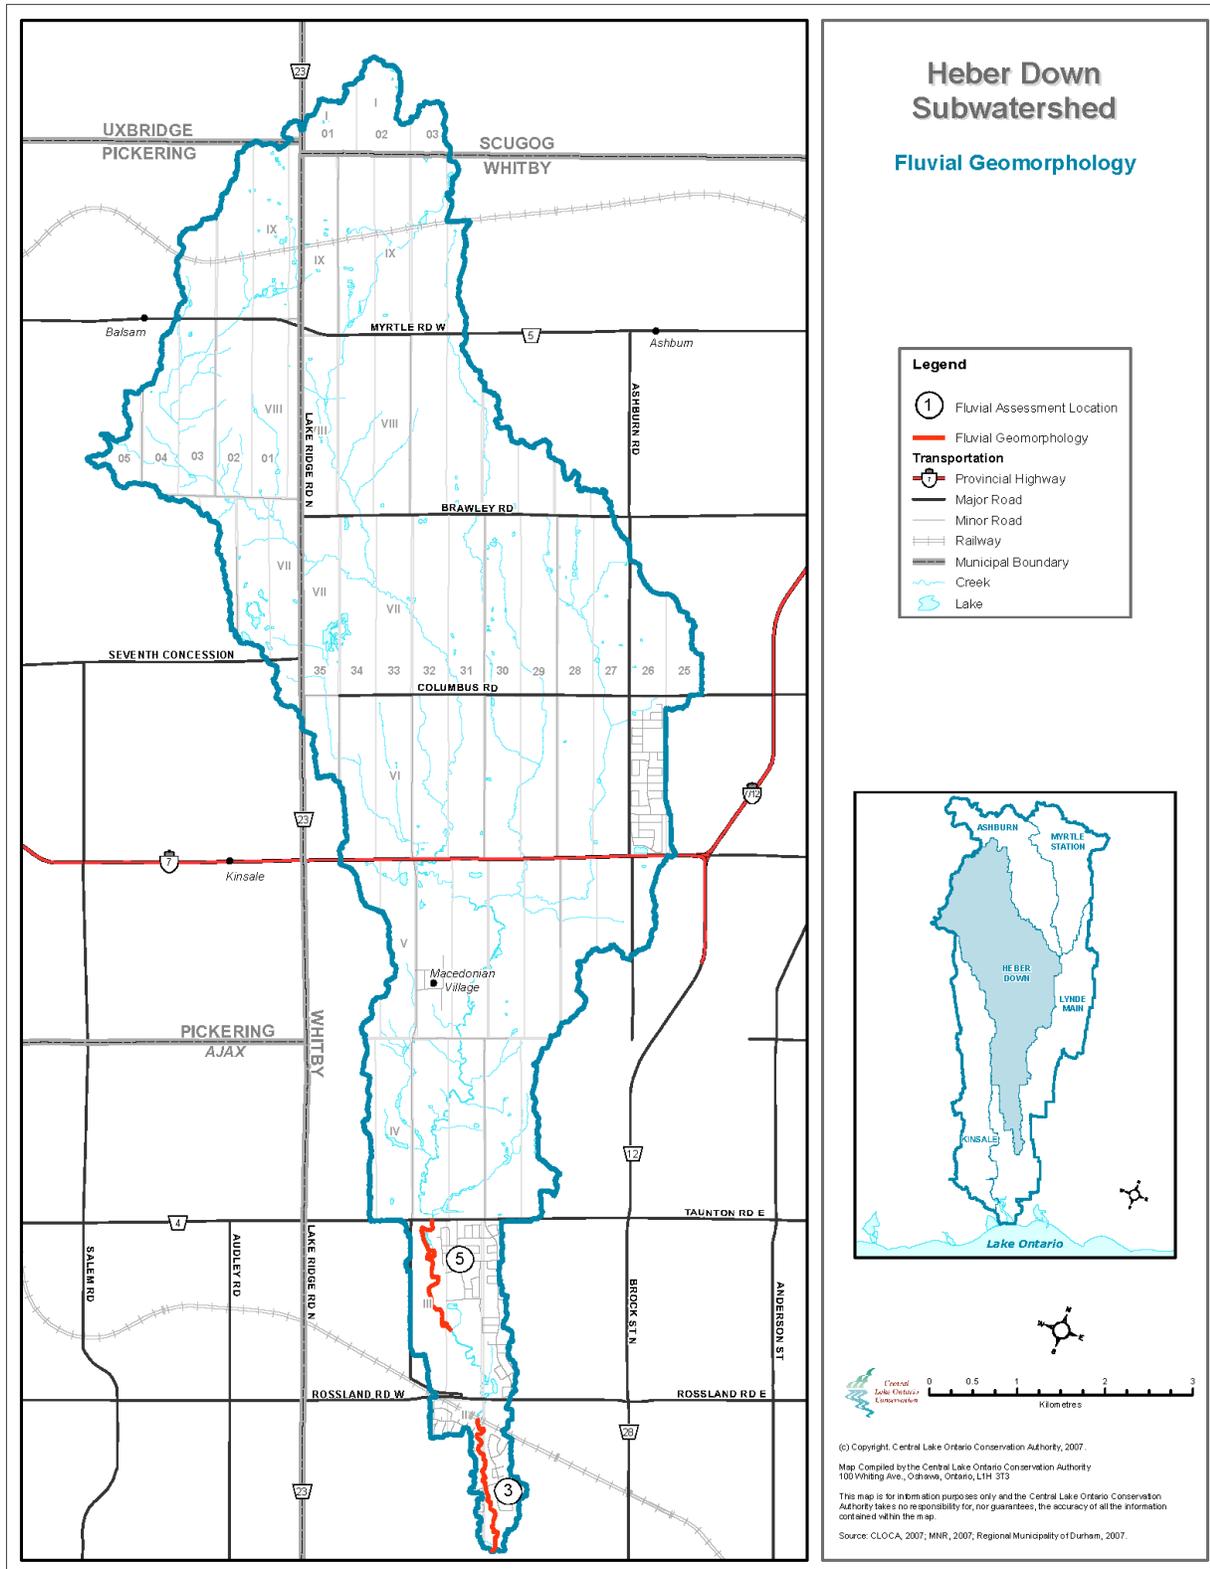
Figure 4: Location of fluvial geomorphic assessments in the Heber Down subwatershed.

Reach 3 is a rapid flowing stream flowing through a broad open floodplain with meadow and sparse dogwood and deciduous tree cover. Lack of riparian cover and channel instability contributed to a “fair” condition rating in the RSA assessment. Although the creek is centred within the open space system, and does not pose a threat to adjacent residential neighbourhoods, there are channel-hardening sites including gabion baskets, armour stone, and rip rap stone. Approximately 200m downstream of Bonnacord Avenue, the stream flows over a section of bedrock, which acts as a grade control structure to prevent stream bed erosion.

The RGA assessment rated this reach as “stressed”, due to evidence of stream widening and plan form adjustment. This reach was noted as an area of many erosion sites (GM Sernas 1988), and a reach with erosion potential (Gartner Lee, 1993).

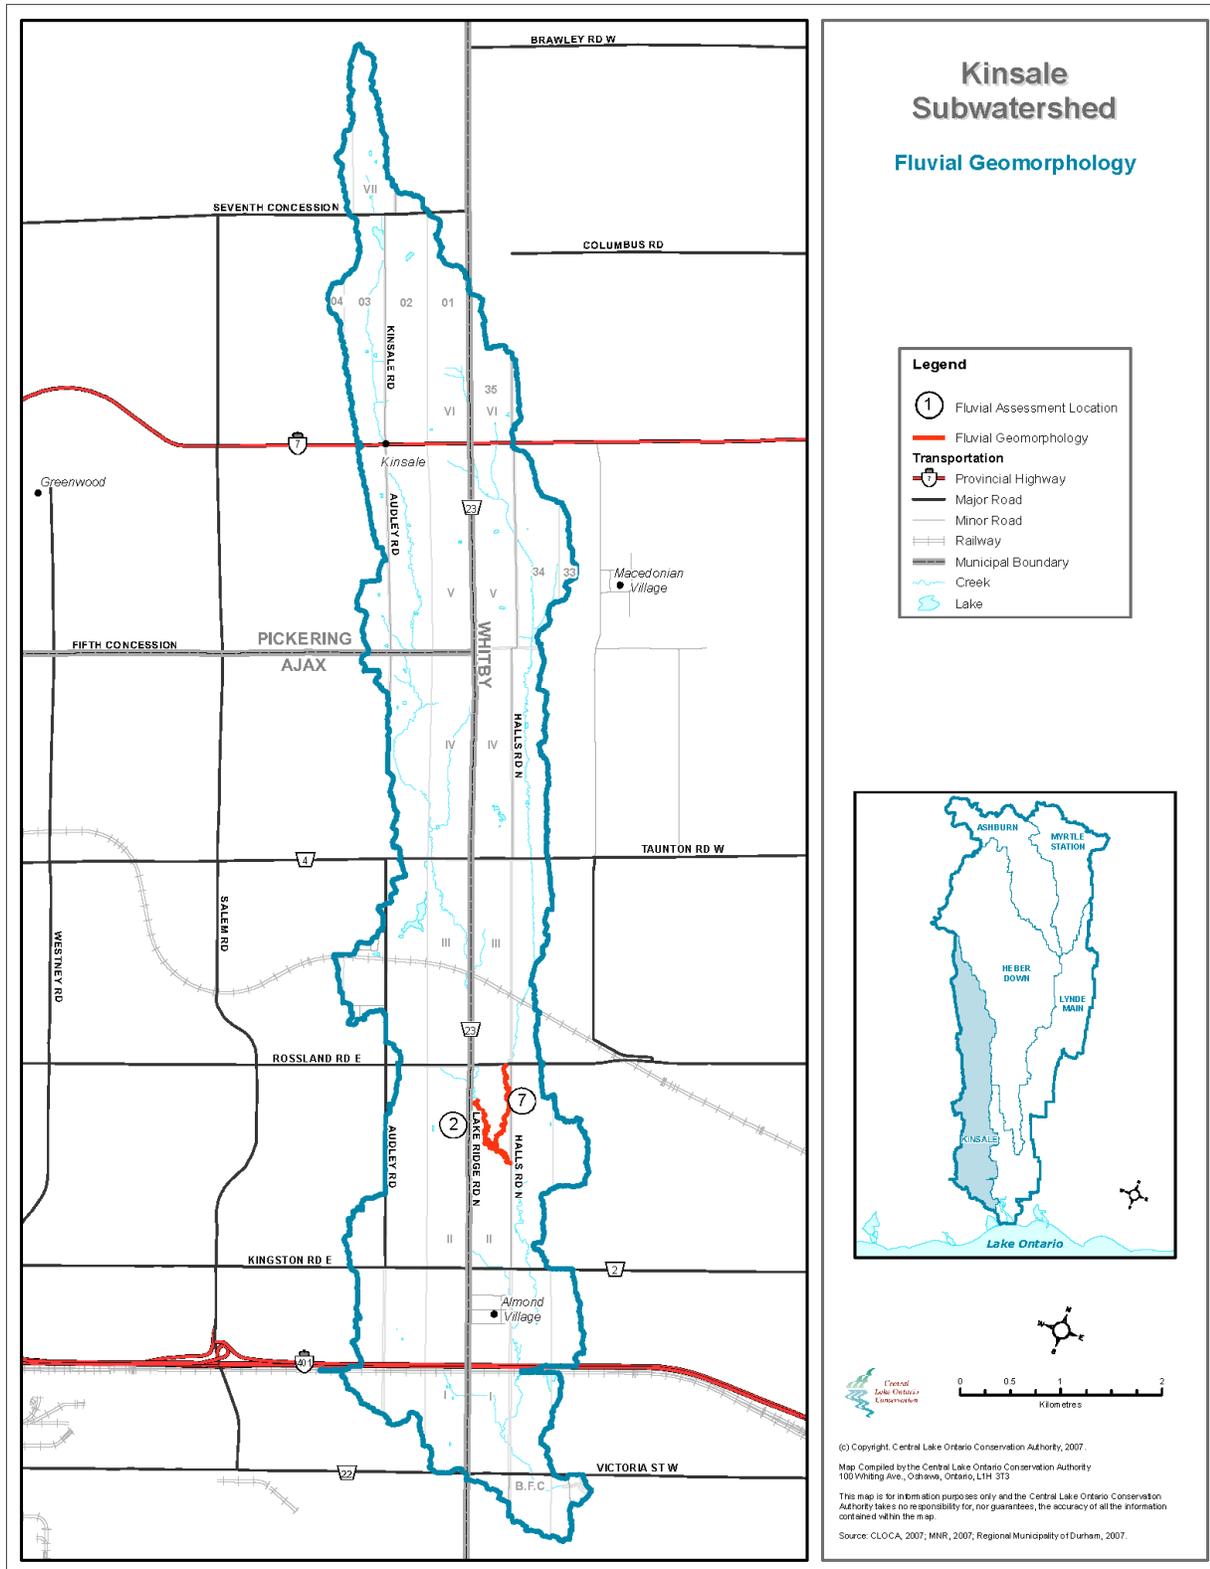
Figure 5: Location of fluvial geomorphic assessments in the Kinsale subwatershed.

This reach scored "good" in the RSA assessment, primarily due to riparian cover. The RGA assessment scored this reach as "in regime", although extensive evidence of channel widening was observed. It appears that this reach has been impacted in the past through forest clearing, pasturing of livestock and physical alterations. Despite these impacts, the reach appears to have adjusted over time (as evidenced by abandoned oxbows) and is currently healthy from a geomorphic perspective.
